**FAILURE OF THE PROTOTYPE WINDFLOW 500 TURBINE'S
GEARBOX HOLDING-DOWN BOLTS
IN A RAPID WIND SHIFT ON 10 MARCH, 2005**

SUMMARY REPORT ON THE CAUSES AND REQUIRED REMEDIES

**BY GEOFF HENDERSON,
CEO, WINDFLOW TECHNOLOGY LIMITED
4 April 2005**

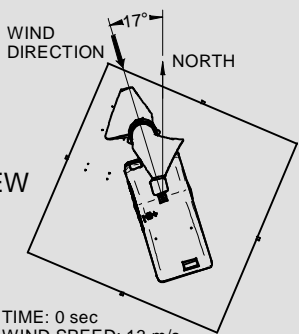
Diagram 1
T=0 sec

- Diagram 1. Turbine operating normally. Wind coming from the NNW about 47 km/h, nacelle facing the wind and rotor turning at about 48 rpm.
- Diagram 2. Wind changes direction quickly (100° in 89 seconds) and increases to 68 km/h from the SW. Turbine's nacelle turns (yaws) to follow the wind direction but only turns 35° in the same time. Nacelle is now sideways to the wind so rotor has slowed down to 41 rpm, initiating a shut-down.

TIME: 0 sec
WIND SPEED: 13 m/s
ROTOR SPEED: 48 rpm
YAW ANGLE: 0°
PITCH ANGLE: 0°
TEETER ANGLE: 0°

RESULTANT OF BLADE LOADS IS DOWNWIND AXIAL FORCE (NO MOMENT)

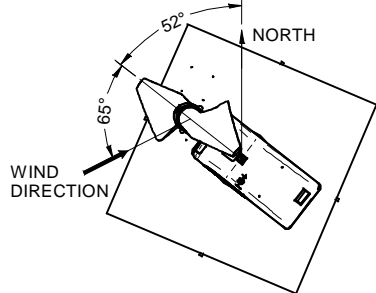
Diagram 2
T=89 sec

TIME: 89 sec
WIND SPEED: 19 m/s
ROTOR SPEED: 41 rpm
YAW ANGLE: 65°
PITCH ANGLE: 0°
TEETER ANGLE: 1.7°

FROM T=56 sec
TURBINE SLOWS
DOWN DUE TO
SIDE WIND

RESULTANT OF BLADE LOADS IS DOWNWIND AXIAL FORCE (NO MOMENT)

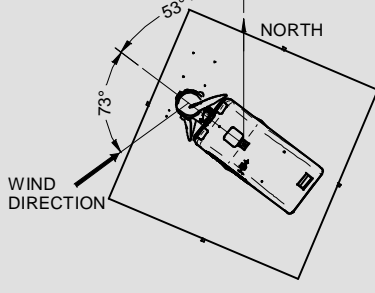
Diagram 3
T=91 sec

- Diagram 3. Within the next two seconds (from T = 89 to T = 91) several things happen:
- blades pitch to slow the rotor down as part of normal shut-down

- wind direction shifts a further 7° south
 - wind speed increases to 90 km/h with a gust at 97 km/h
- Diagram 4. The combination of these events create high reverse loads on the upper vertical blade and cause the bolts holding the gearbox on the pallet to yield and break.

TIME: 91 sec
WIND SPEED: 25 m/s
ROTOR SPEED: 35 rpm
YAW ANGLE: 73°
PITCH ANGLE: 24°
TEETER ANGLE: -6°

TURBINE STARTS TO
SHUT DOWN DUE TO
SLOW SPEED

RESULTANT OF BLADE LOADS IS UPWIND AXIAL FORCE

LARGE MOMENT
CAUSES ROTOR
TO TEETER AND
HUB TO IMPACT
TEETER STOP ON
LOW SPEED SHAFT

1. The effective yaw rate will increase in such circumstances

2. The underspeed shut-down software will be amended so that an underspeed will not trigger a shut-down in similar circumstances.
3. The shut-down software will be amended so that the brake is applied rather than blade pitching in certain circumstances.

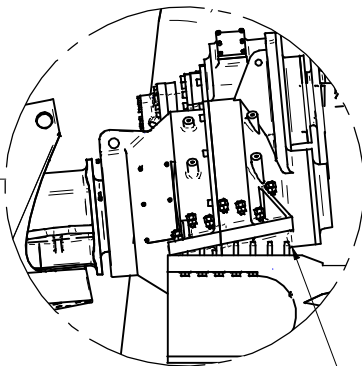
Diagram 4

In such a severe wind shift, the nacelle did not yaw fast enough and the turbine began to shut down as it sensed an underspeed situation. This resulted in reverse loads on the rotor which subjected the gearbox bolted joint to overturning moments which were more than 2.87 times the maximum design moment.

Having said that, Grade 12.9 instead of Grade 8.8 bolts could be used which will increase the yield strength of the bolted joint by 50% and increase the safety factor from 2.87 to 4.30.
